ROI Case Study -1

Location – Large Organisation

Description – Asset Register – Visual Inspection

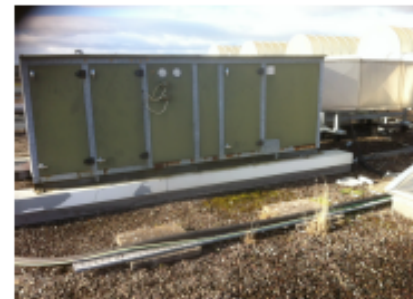
1. Unreported damaged to 2 Air Handling Units

In both cases all the door hinges for the various sections of each AHU had rusted / rotted away with the result the doors were only secured by the latch and in one case a wooden beam. Very little force was required for the doors to disengage and fall on the ground, exposing the interior controls and components to the weather. Heavy water ingress would have resulted in major if not total damage to the AHU. Cost of replacement approx. €20,000 ea. Cost of repairing the damage (replace hinges) €300 ea.

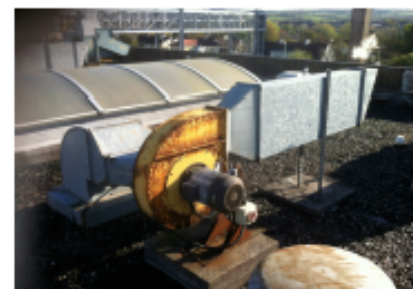
2. Heavy Corrosion to Extract Fans

There are many roof extract fans on site. On one particular model (20+ units) the cowl over the fan is very prone to weather corrosion. In many cases the corrosion was such that 'breakthrough' would occur in less than two years, resulting in potential failure of the extract unit. Cost of replacement approx. €4,000 ea. Cost of repairing the damage (cleaning & painting) €50 ea.

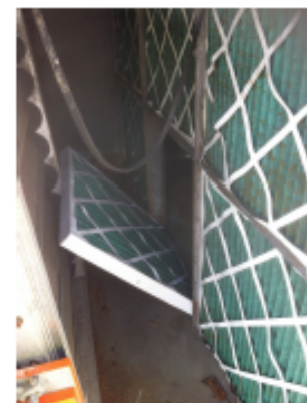
3. Filter Damage AHU's

Filters are a key element of AHU's, they clean the air going into the building and protect the interior of the AHU. These are usually replaced 2 to 4 times pa. On this site it was obvious that the filters had not been changed for up to 2 years and some had collapsed. This resulted in dirty and damp air being forced into the building interiors. A known cause of "sick building syndrome". Cost to replace a single filter €4.
